ALABAMA HAZARDOUS WASTES MANAGEMENT AND MINIMIZATION ACT (AHWMMA)

Compliance Evaluation Inspection (CEI) Report

United Launch Alliance- Decatur Operations (ULA)

12/3/2019

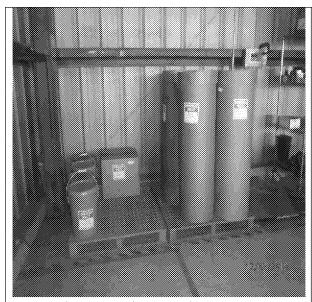
Universal Waste in the Hazardous waste Storage Area
